CIVIL AERONAUTICS BOARD

ACCIDENT INVESTIGATION REPORT

AMERICAN AIRLINES, INC.,—ELIZABETH, NEW JERSEY, JANUARY 22, 1952

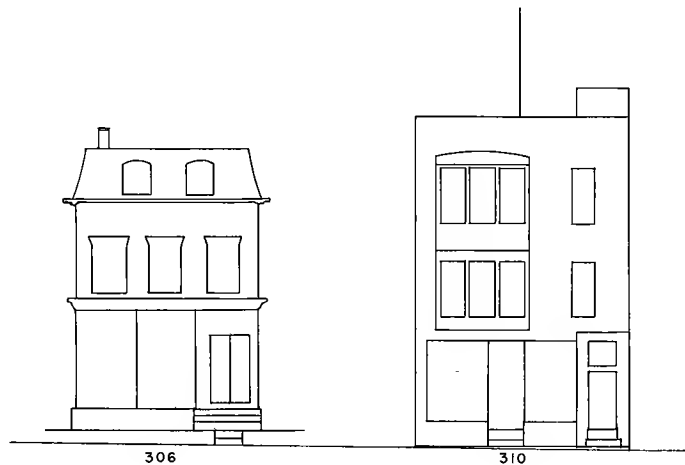
Actual investigation of the wreckage of aircraft and buildings reveals that the aircraft struck while about level laterally, on a heading of approximately 90° true, but

while in steep descent, with the nose raised appreciably. Marked localization of the wreckage further substantiated this nature of impact, i.e., with considerable vertical, but relatively little horizontal, speed.⁶ There was no evidence of any fire in flight. A protracted and highly destructive ground fire eliminated a great deal of physical evidence pertaining to aircraft structure and power plants. It was nevertheless possible to learn certain conditions existing prior to impact.
